"The Valley Comes Alive with 88.5"

Technical Report

Supporting Grant Application.

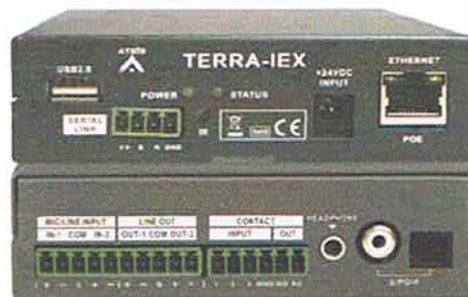
TERRA-IEX CHARACTERISTICS

- 2 Mic/line balanced inputs
- 2 independent balanced line outputs
- 1 headphone output on mini-jack
- 1 SPDIF Transceiver - optional
- Audio inputs: maximum level + 5 dB, bandwidth 20 Hz - 20 kHz
- Audio outputs: maximum level + 5 dB, bandwidth 20 Hz - 20 kHz
- Ethernet interface including POE (Power Over Ethernet)
- 24 VDC power supply (if no POE available)
- G.711, G.722, MP3 audio encoding/decoding
- 1 USB port for USB memory stick
- Power & Status LED
- IR receiver - optional
- 3 contact inputs
- 1 relay output
- RS 232 on Euro Block
- Power consumption: 3 W
- Weight: 434 g
- Dimensions (mm): Depth 104, Height 32, and Width 109.

TERRA-IEX is a 2 channel audio over IP encoder/decoder.

The balanced line input can be used as an audio source for your IP network, like a cd player or a sound card of a PC and be encoded in high quality MP3. A microphone can also be plugged on the mic input and be encoded in G.722. An optional S/PDIF input can also be used as a source. The TERRA-IEX streams its inputs in unicast or multicast. The same device provides also 2 independent balanced outputs for half-duplex communication or for local outputs.
